FINAL REPORT SEPTEMBER 2003

REPORT NO. 03-16

MODULAR STORAGE AND TRANSPORT FRAME (MSTF) LOW, MIL-STD-1660, "DESIGN CRITERIA FOR AMMUNITION UNIT LOADS" TESTING

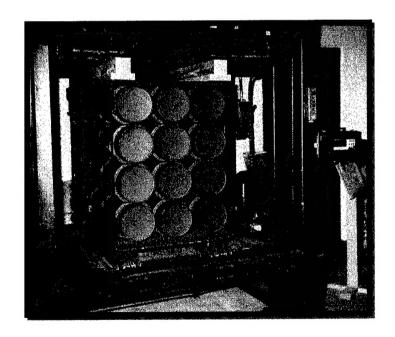
Photo 1. Example of Stacking Test.(2.75-inch Hydra 70, PA151 Rocket Pallet in the Stacking Test.)

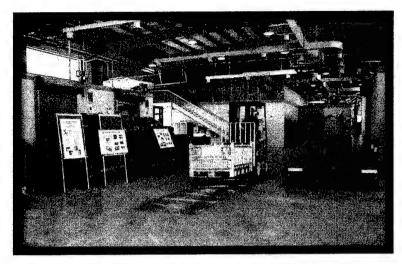
Photo 10. MSTF Low Test Unit #1 With Wooden Dunnage

6. <u>FORKLIFTING TEST</u>. The specimen was lifted clear of the ground by a forklift from both longitudinal sides and both lateral sides and transported. Photo 10 shows the specimen during the Forklifting Test. No damage was noted as a result of this test.

- 7. <u>DISASSEMBLY TEST</u>. Inspection revealed bent wire mesh, cracked welds along the wire mesh and one cracked weld in the base structure. The specimen maintained adequate integrity and was still considered safe to handle.
- 8. <u>CONCLUSION</u>. As tested, the Modular Storage and Transport Frame (MSTF) Low Test Unit #1, with wooden dunnage, manufactured by Mobile Shelter Systems, successfully completed the MIL-STD-1660 test requirements.
